Reference: EPA Contract No. 68-W9-0040; Work Assignment
No. R04-19-14; Occidental Chemical; Muscle
Shoals, Alabama; EPA I.D. No. ALD004019642;
RCRA Facility Assessment; Final Deliverable

Enclosed please find the RCRA Facility Assessment (RFA) for the above-referenced facility. This report presents the results of the Preliminary Review (PR) and the Visual Site Inspection (VSI). The RFA resulted in the identification of 25 Solid Waste Management Units (SWMUs) and 4 Areas of Concern (AOCs).

The Occidental Chemical Corporation (OxyChem) facility in Muscle Shoals, Alabama is a chlor-alkali plant that currently produces chlorine, potassium hydroxide, potassium carbonate, and hydrogen gas. For several decades and until 1991, the facility also produced sodium hydroxide.

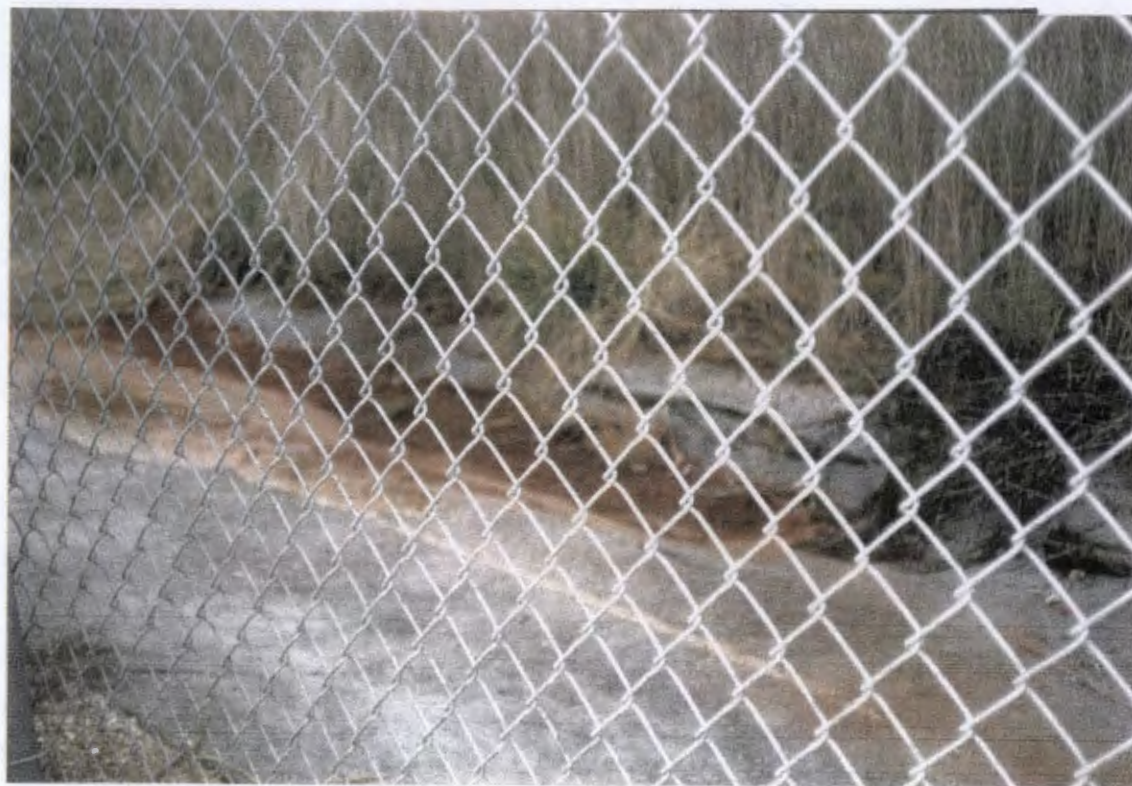
Photographs 1.1 and 1.2 (see Appendix B) show an asphalt lined perimeter ditch that extends along the southwestern side of the landfill. Close inspection of the ditch revealed several areas where the earth beneath the ditch had subsided to such an extent that the asphalt liner had broken up.

1.1 Close-up of the asphalt lined perimeter ditch that extends along the southwestern side of the Landfill (SWMU 1).

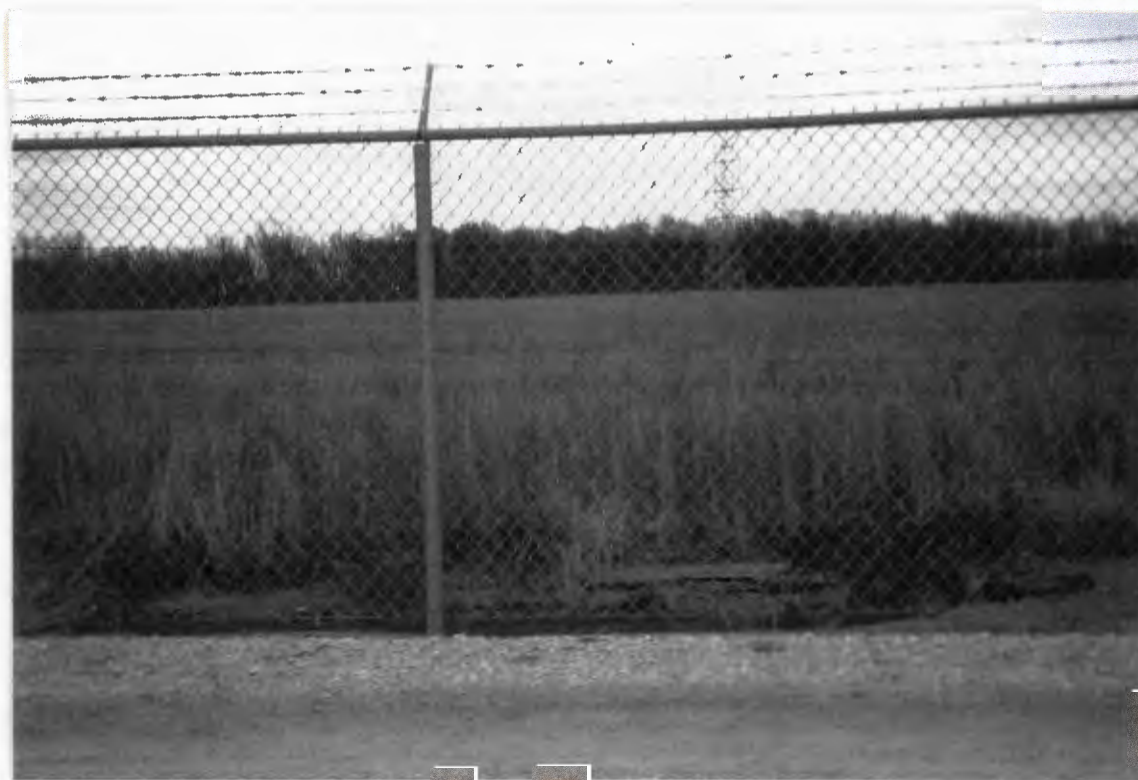
1.2 View of the Landfill (SWMU 1) from the south side of the perimeter ditch.

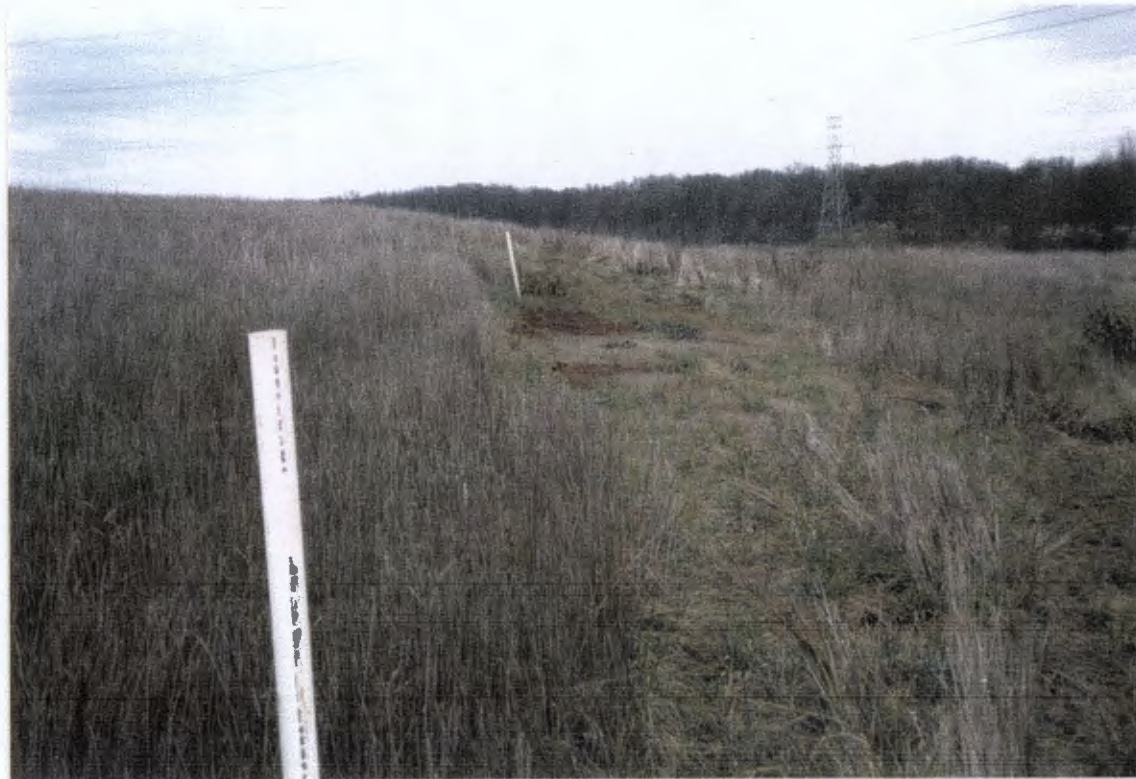
1.3 Area along the northeastern side of the Landfill (SWMU 1) with the PVC pipes that mark the edge of the geomembrane.

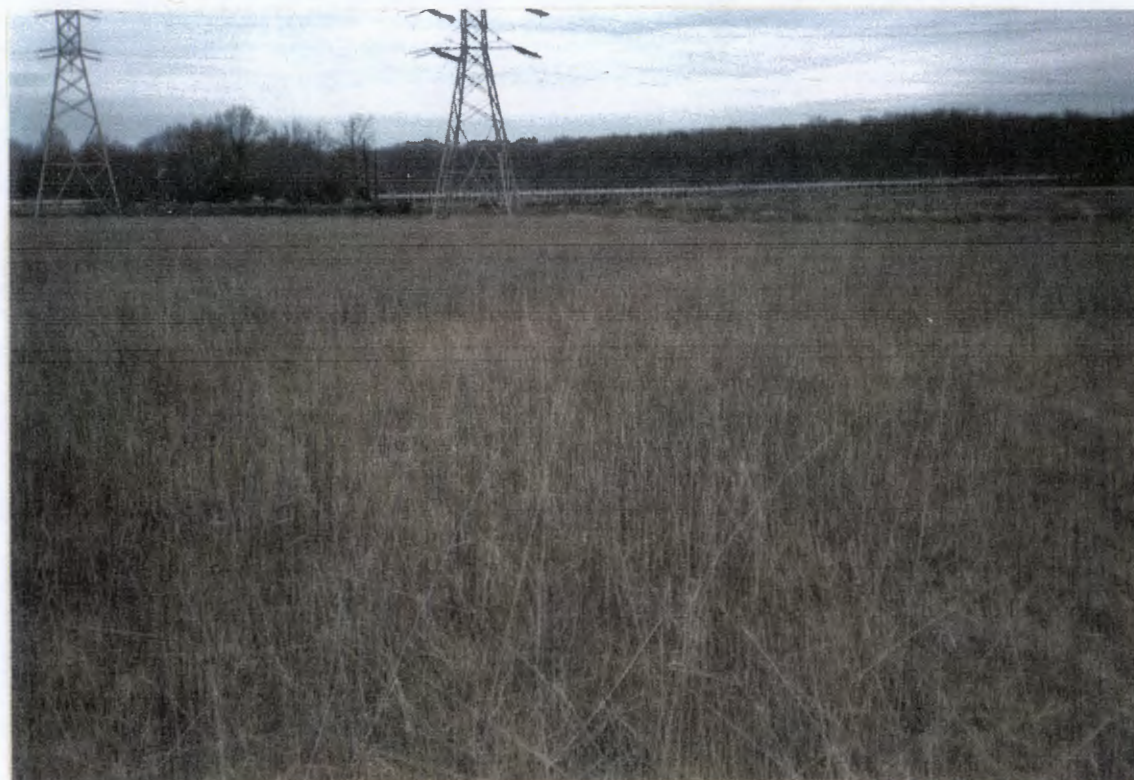
1.4 Area of good vegetative cover on the Landfill (SWMU 1).

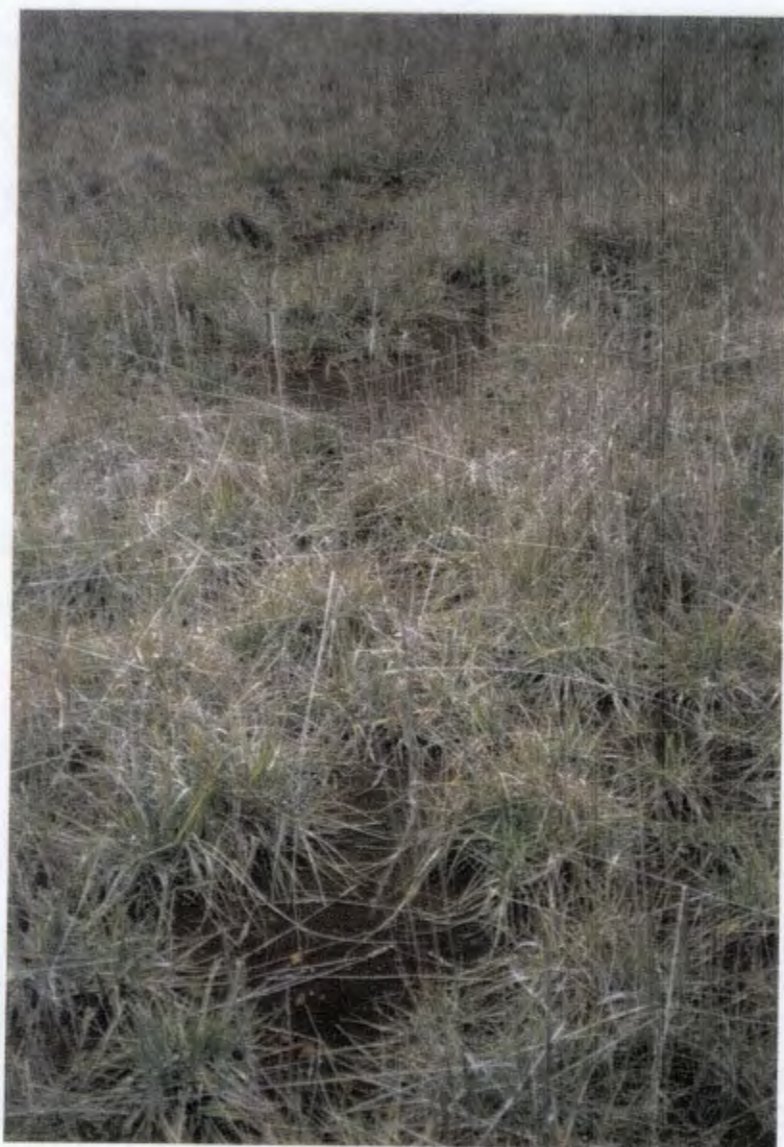
1.5 Bare areas on the Landfill (SWMU 1) cover.

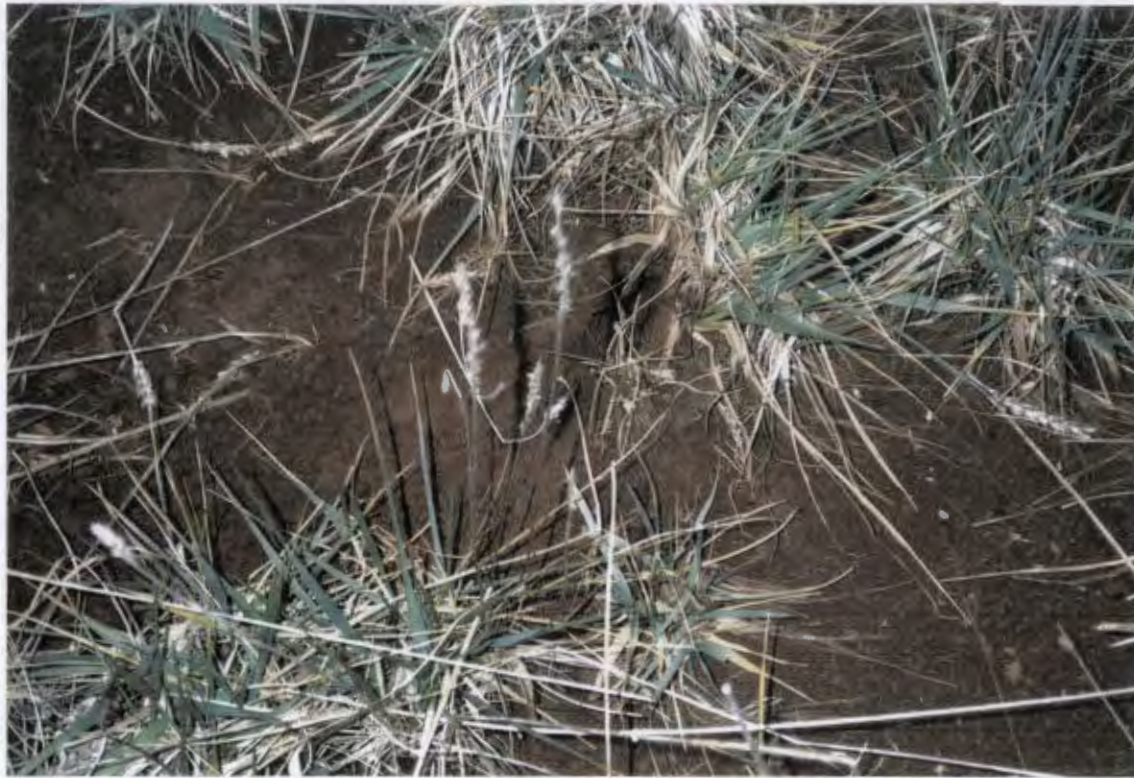
1.7 Hole in the cover of the Landfill (SWMU 1) created by animal activity.

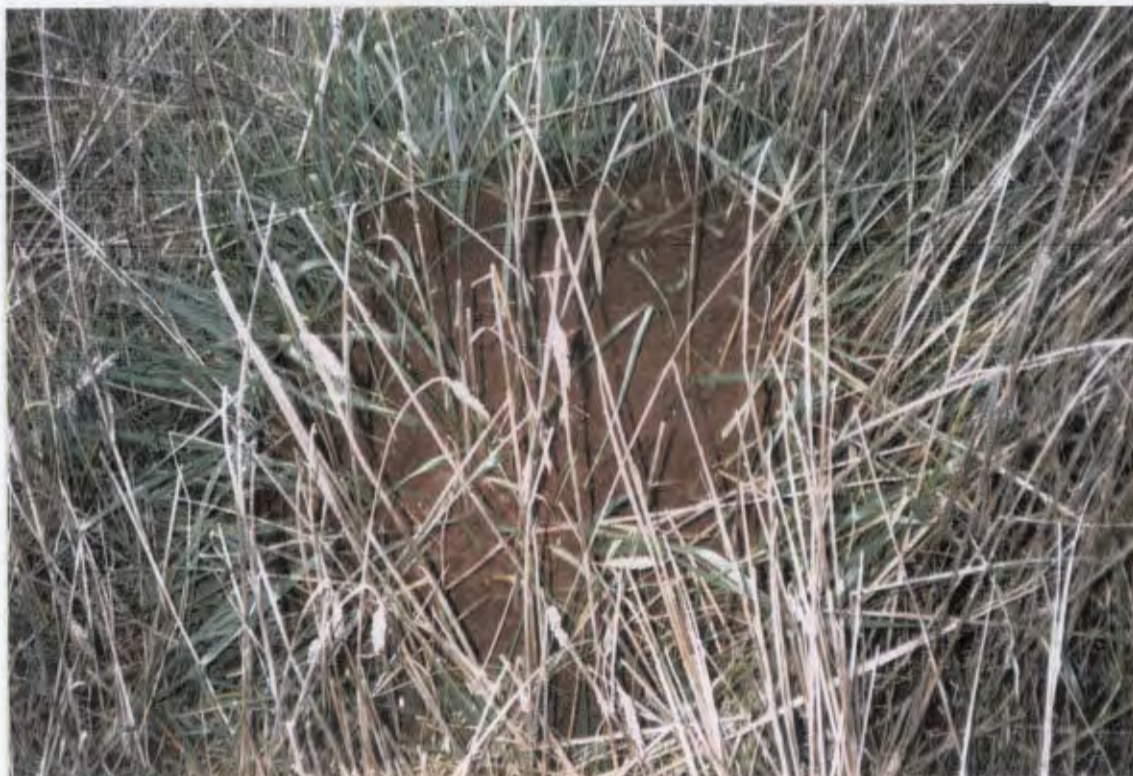
1.8 An ant hill on the cover of the Landfill (SWMU 1).

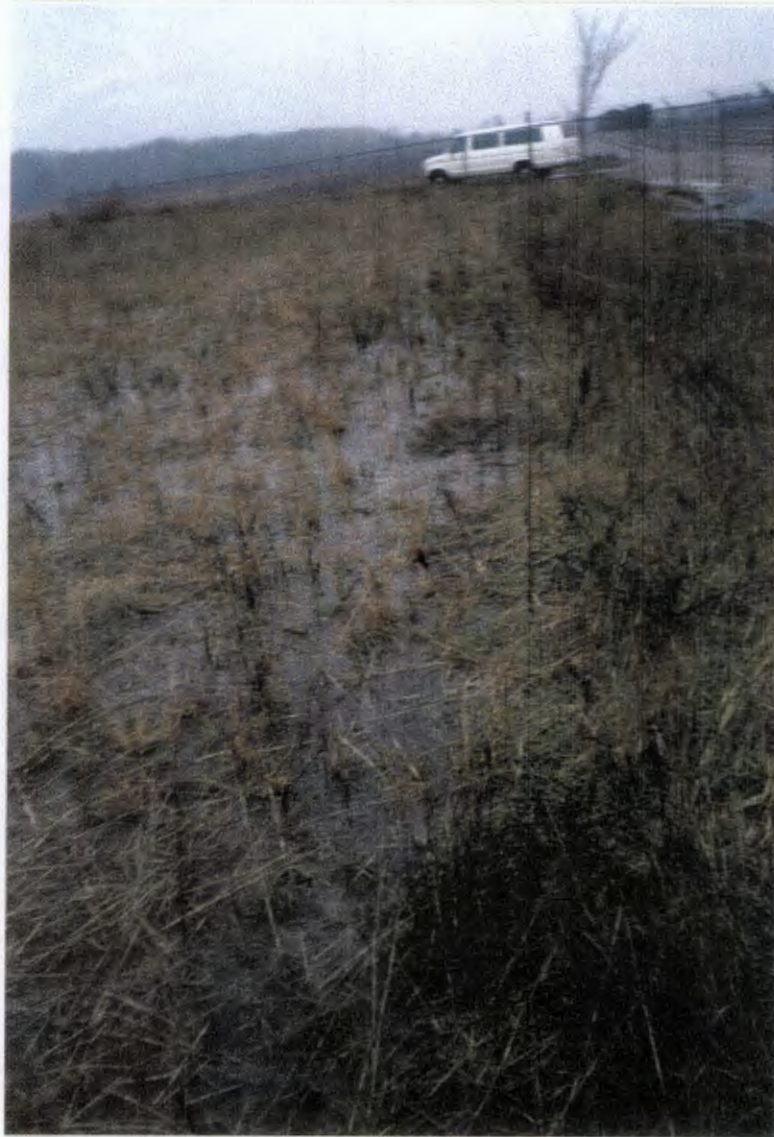
1.13 Area of standing water on the Landfill (SWMU 1)
following a precipitation event (looking east toward the
Landfill (SWMU 1) gate).

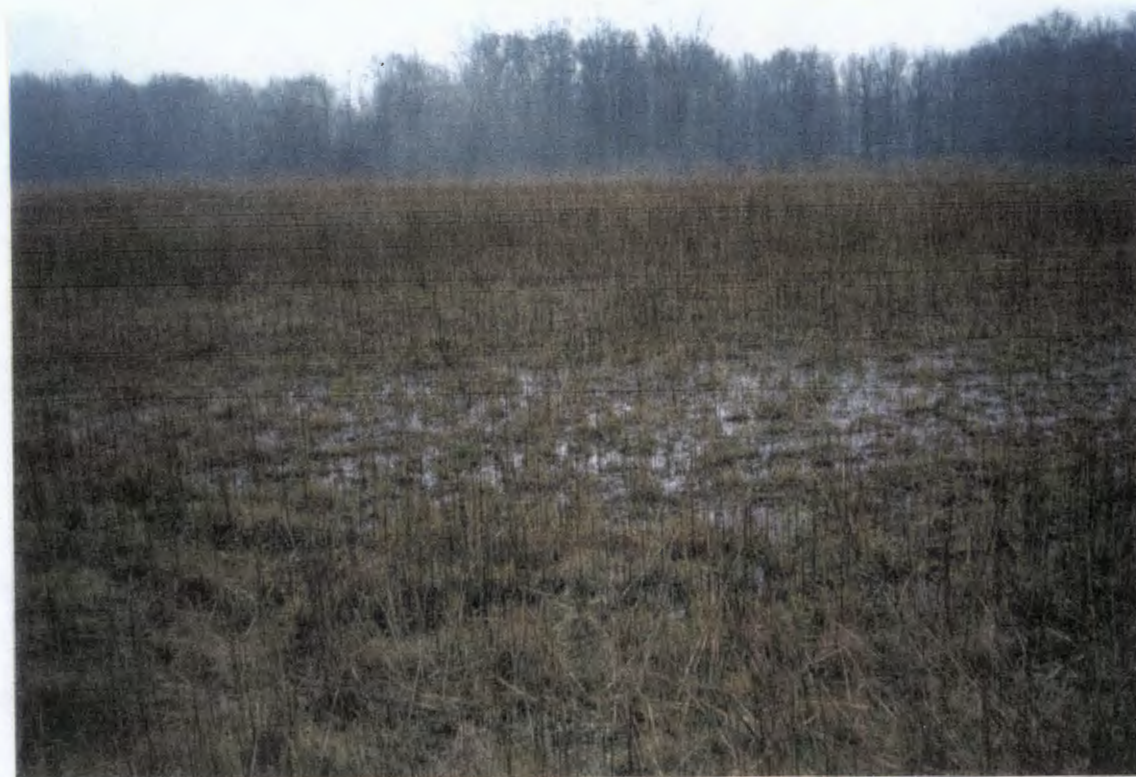
1.14 Area of standing water on the Landfill (SWMU 1) following a precipitation event (looking north across the Landfill).

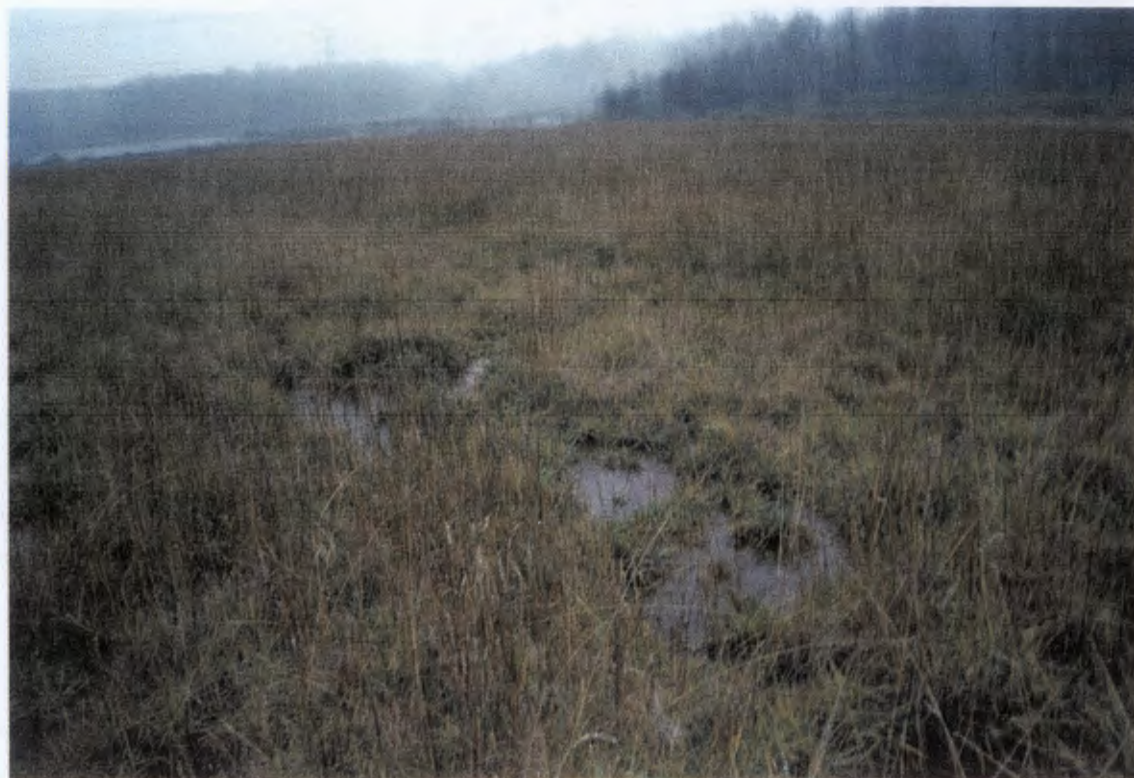
1.15 Area of standing water on the Landfill (SWMU 1) following a precipitation event (looking northwest across the Landfill).

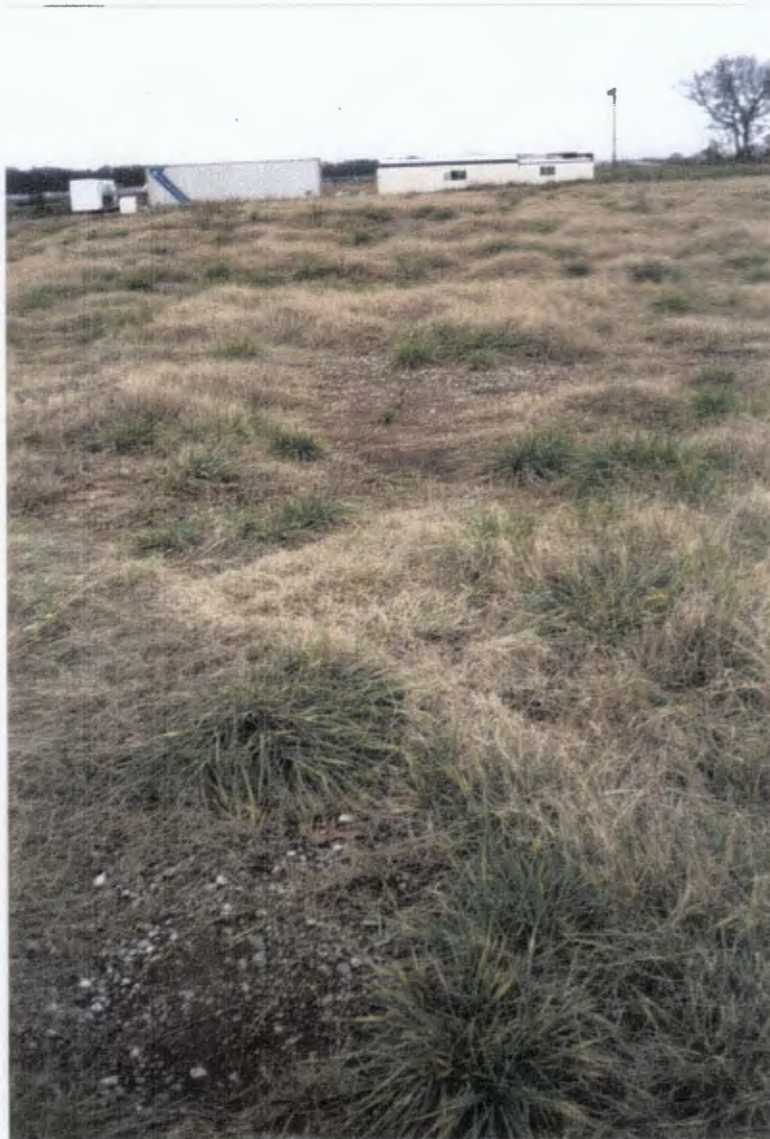
2.3 Bare areas on the backfilled surface of the Former South Impounding Basin (SWMU 2).

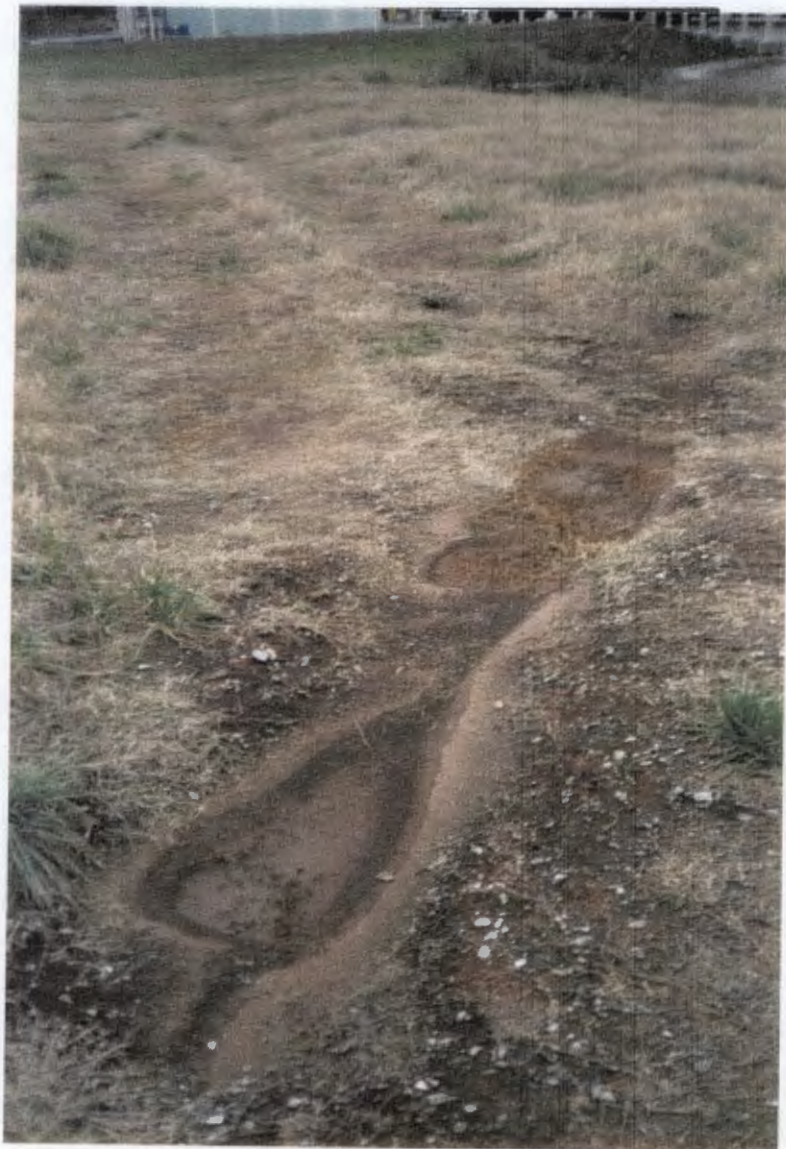
2.4 Close-up of a bare spot on the backfilled surface of the Former South Impounding Basin (SWMU 2).

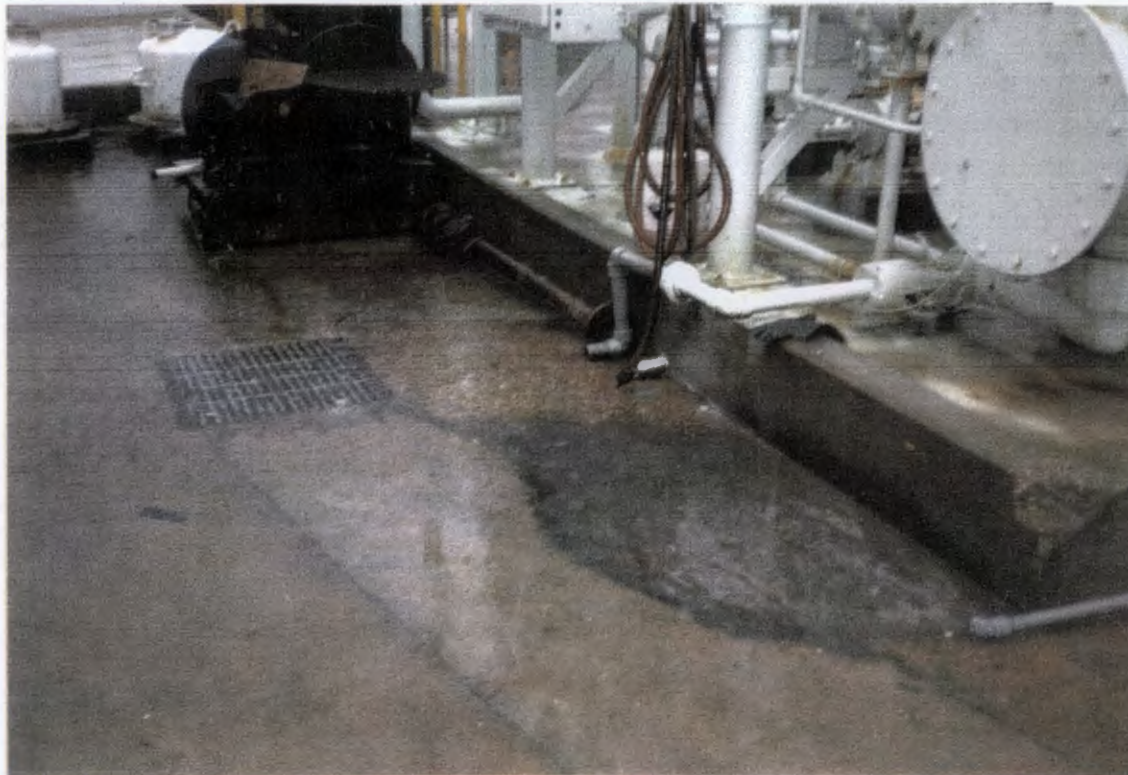
10.2 Close-up of stains on concrete indicating the mercury wastewater path to stormwater sewer system.

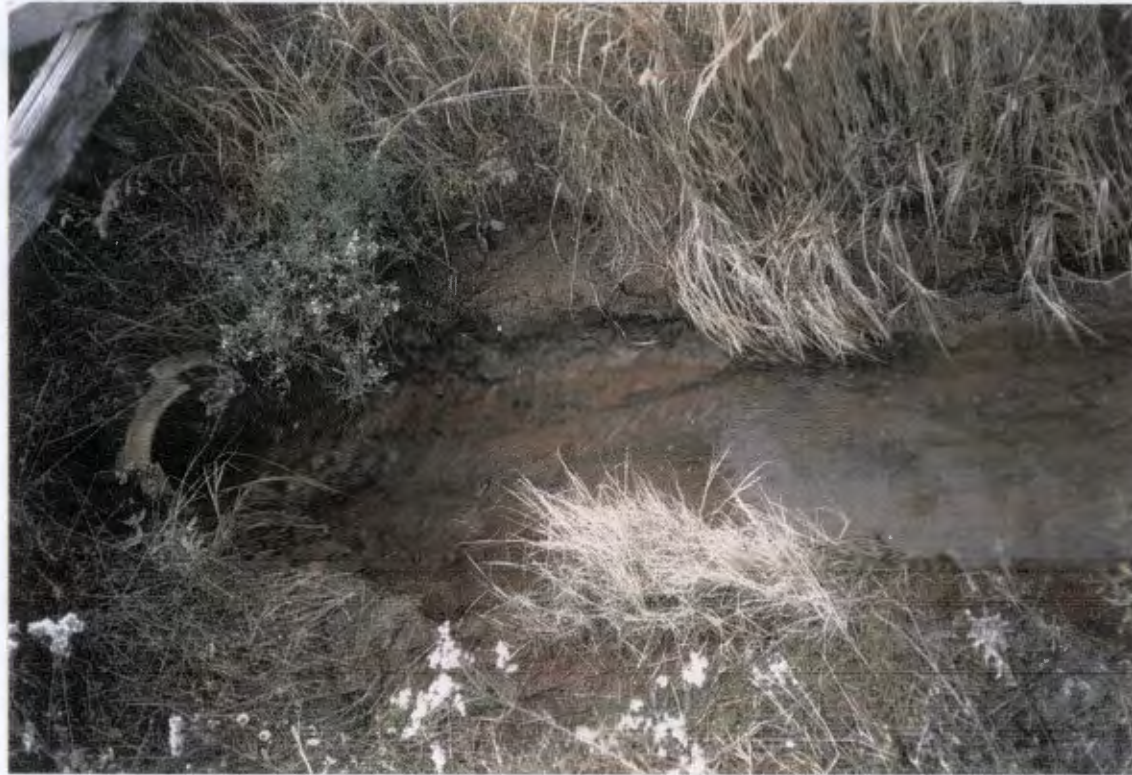
14.3 Outfall (for the sewer shown in Photograph 14.2 and located approximately 100 feet east of the manhole cover shown in Photograph 14.1) which drains into the Old East Outfall Ditch (SWMU 15).

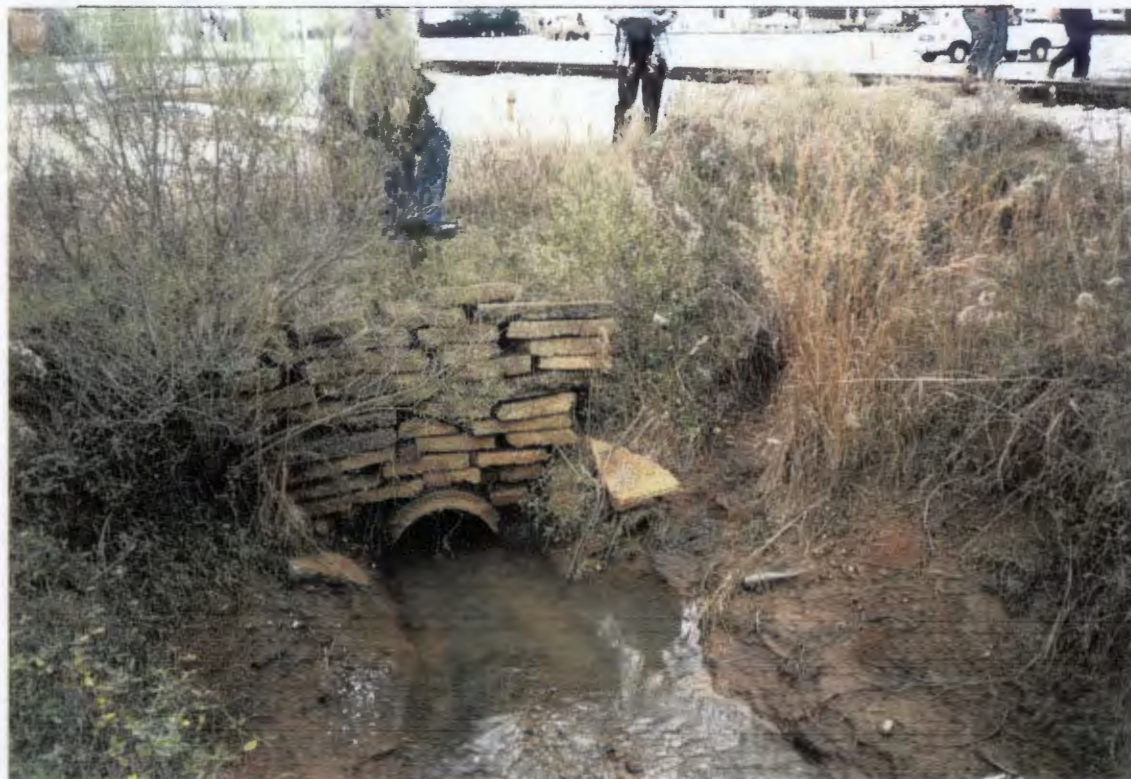
14.6 Outfall (for the sewer shown in Photograph 14.5 and located approximately 100 feet east of the manhole cover shown in Photograph 14.4) which drains into the Old East Outfall Ditch (SWMU 15) approximately 400 feet north of the outfall depicted in Photograph 14.3.

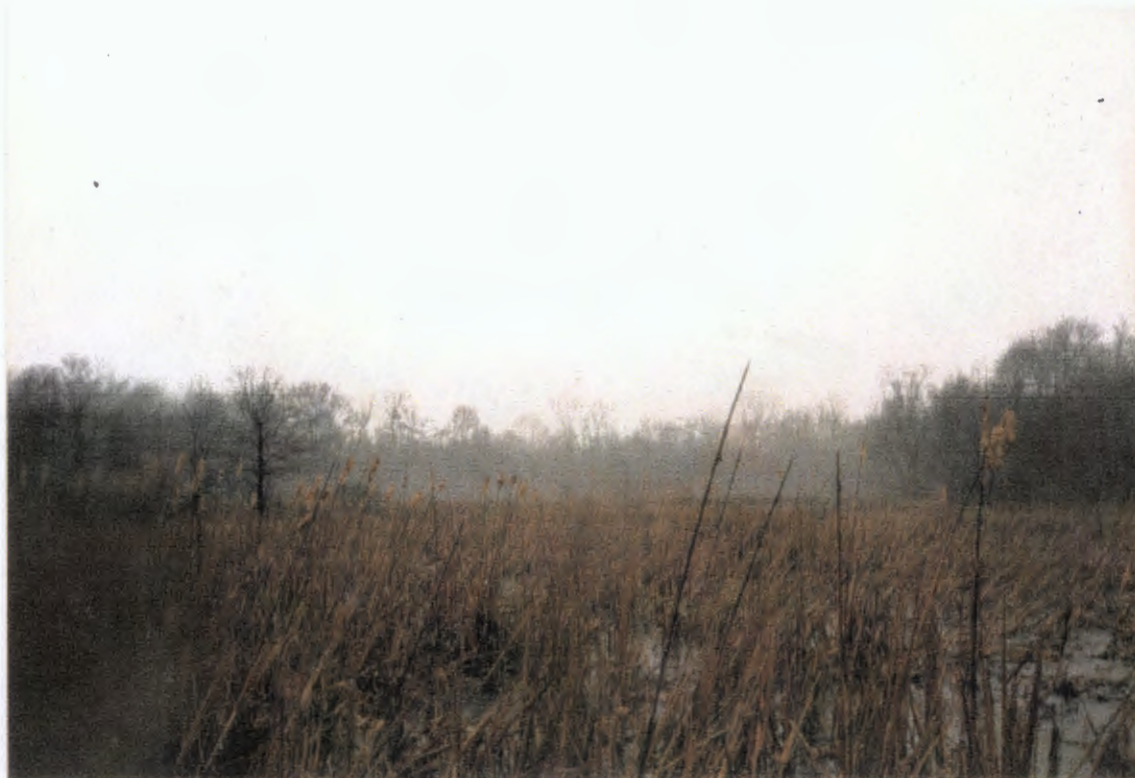
24.2 Close-up view looking southeast across the Stressed Vegetation Area (SWMU 24) south of the plant fence and southwest of the Former South Impounding Basin (SWMU 2).

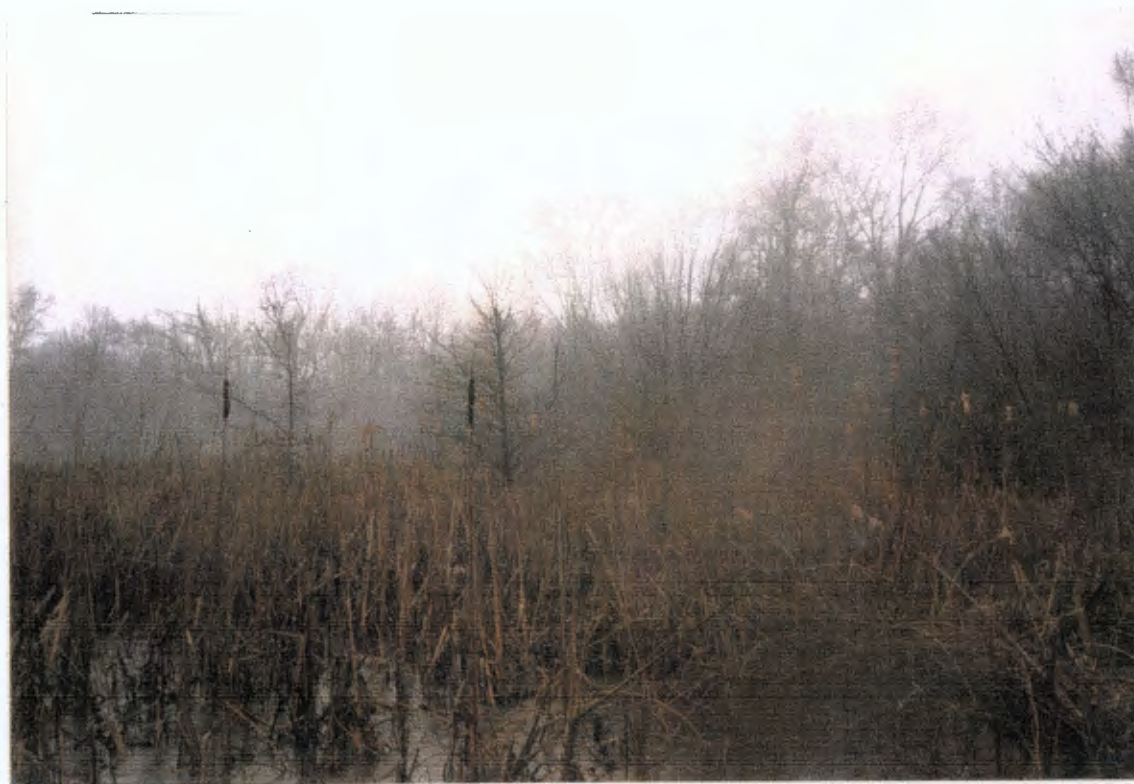
24.3 Close-up view looking south across the Stressed Vegetation Area (SWMU 24) south of the plant fence and southwest of the Former South Impounding Basin (SWMU 2).

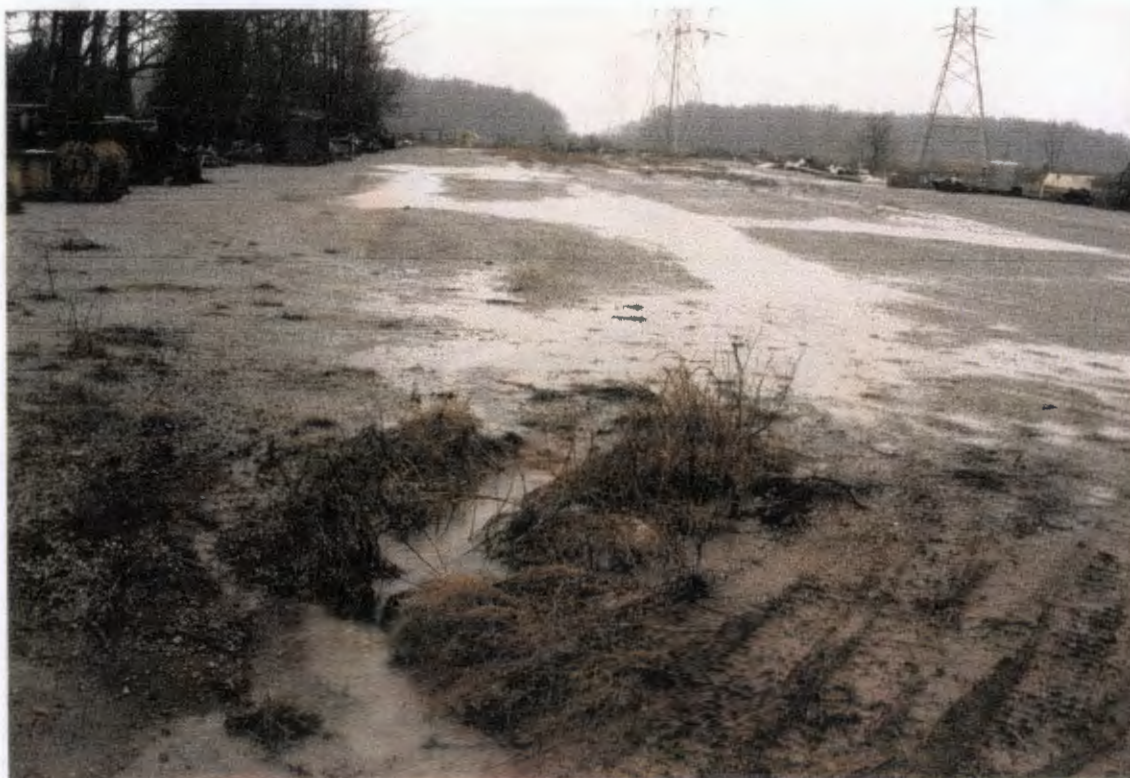
A.3 Runoff exiting the western end of the Junkyard (AOC A).

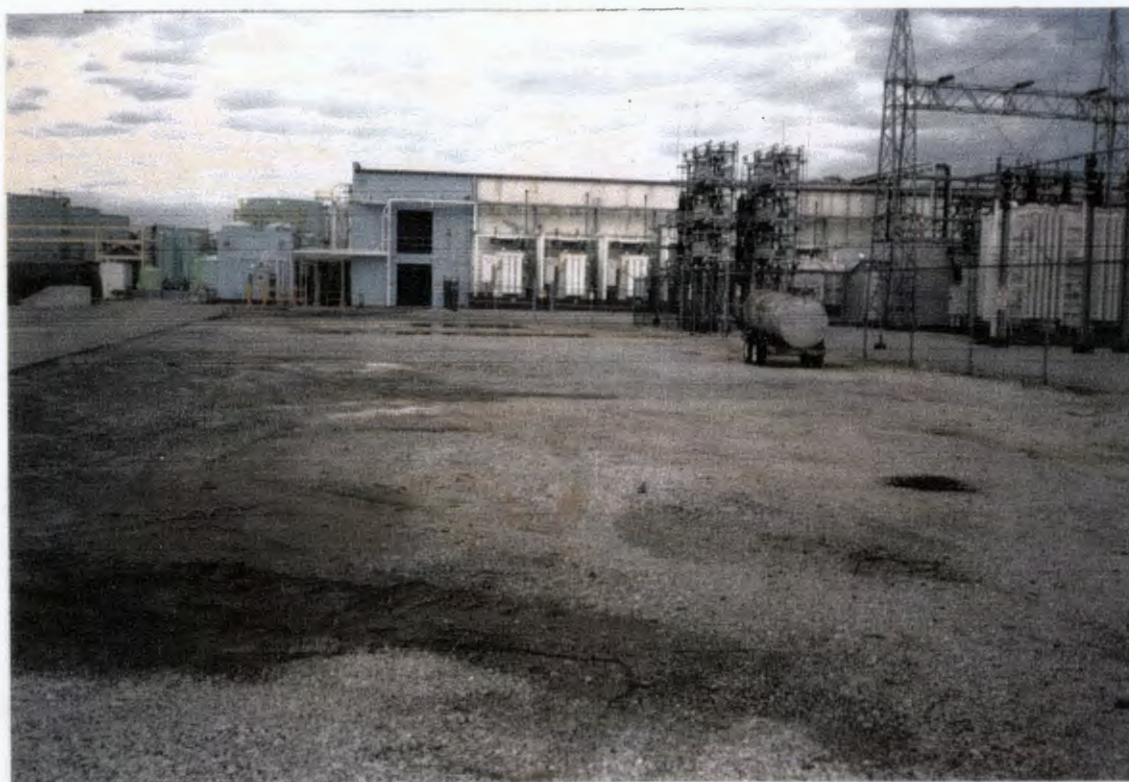
C.1 **Stains on gravel in an area 20 feet south of the electric substation and 200 feet northwest of the manhole cover in Photograph 14.1.**
